**USAAVLABS TECHNICAL REPORT 66-32**

**FULL-SCALE DYNAMIC CRASH TEST OF  
A SMALL OBSERVATION TYPE HELICOPTER**

**May 1966**

**U. S. ARMY AVIATION MATERIEL LABORATORIES  
FORT EUSTIS, VIRGINIA**

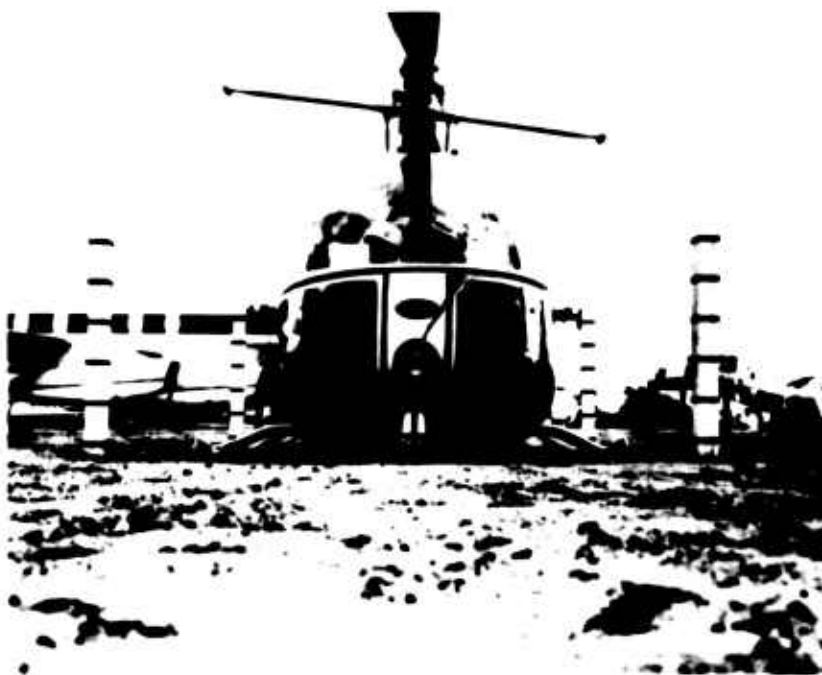
Figure 13 is a close-up view of the right side of the aircraft, showing the deformed skid cross member directly below the pilot's seat. Figure 14 is a postcrash rear view of the aircraft, showing the manner in which the skid cross members deformed at impact. Figure 15 is a postcrash front view of the aircraft.

**Figure 15. Postcrash Front View of the T-21 Aircraft.**

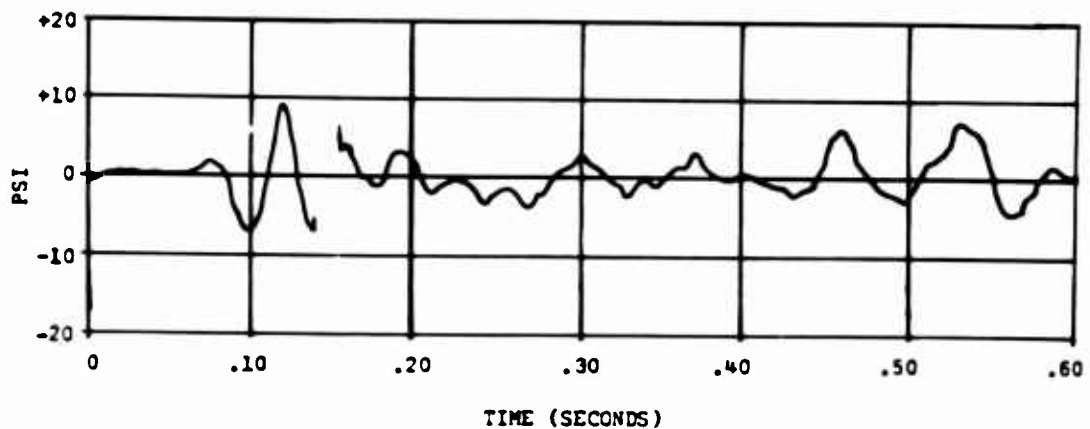
In the two tests conducted, neither the fuel cell nor the surrounding structure failed. Overpressures, measured near the front center of the fuel tank, reached maximums of 38 psi in T-21 and 10 psi in T-22 (Figures 19 and 20). In T-22, there was a small amount of leakage (estimated at less than 1 gallon) from the fuel tank vent due to the final attitude of the aircraft (Figure 21). Had real fuel been used in the tank, it is quite possible that a fire would have occurred, since the engine continued to operate for approximately 2 minutes after the crash and flames and sparks from the engine were noted near the spillage area. However, it is very unlikely that the tank would have exploded, since there was no vapor trail to the interior of the tank. The fire would have been localized around the vent, and the hazard to human life would have been small. Due to the small amount and limited area of spillage, no plot of the spillage area was made.

Figure 20. Pressure-Time Plot of Fuel Tank, T-22.

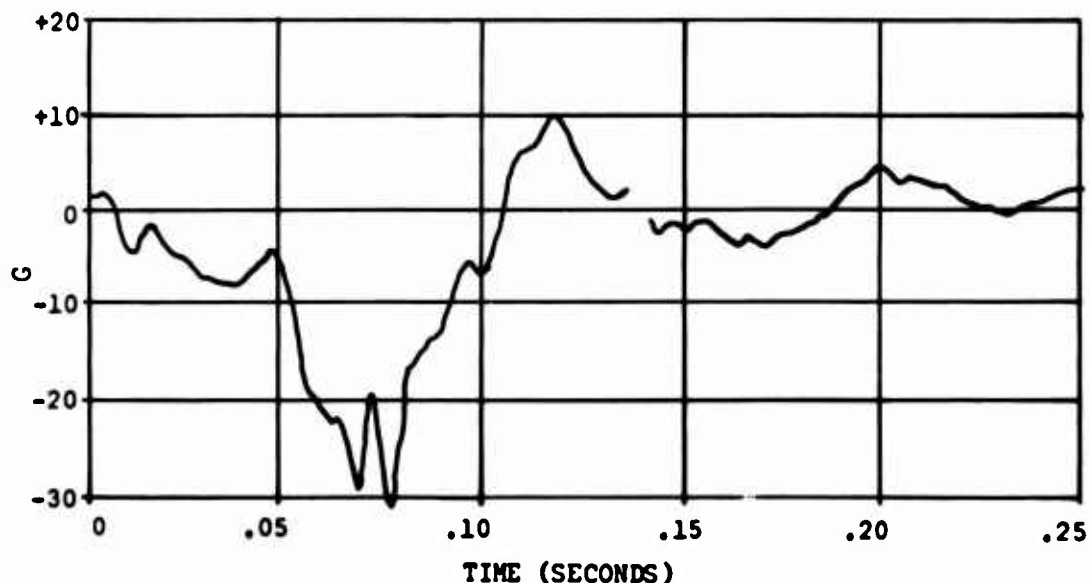
The stiffened honeycomb fuselage structure offers two disadvantages over the conventional frame-skin construction. First, the vertical acceleration in flat impacts is unattenuated since there is little deformation of the structure. This deformation is needed to provide the appropriate "deceleration distance" to reduce floor-level deceleration values. Figures 24 and 25 show the cockpit floor and the passenger floor vertical accelerations for T-21. Even in this 25 ft/sec impact on soil where the landing gear reduced the vertical velocity at impact of the fuselage proper to about 16 ft/sec, the accelerations averaged 25G and 38G peak values, respectively.

Figure 24. Vertical Acceleration-Time Plot of Cockpit Floor, T-21.

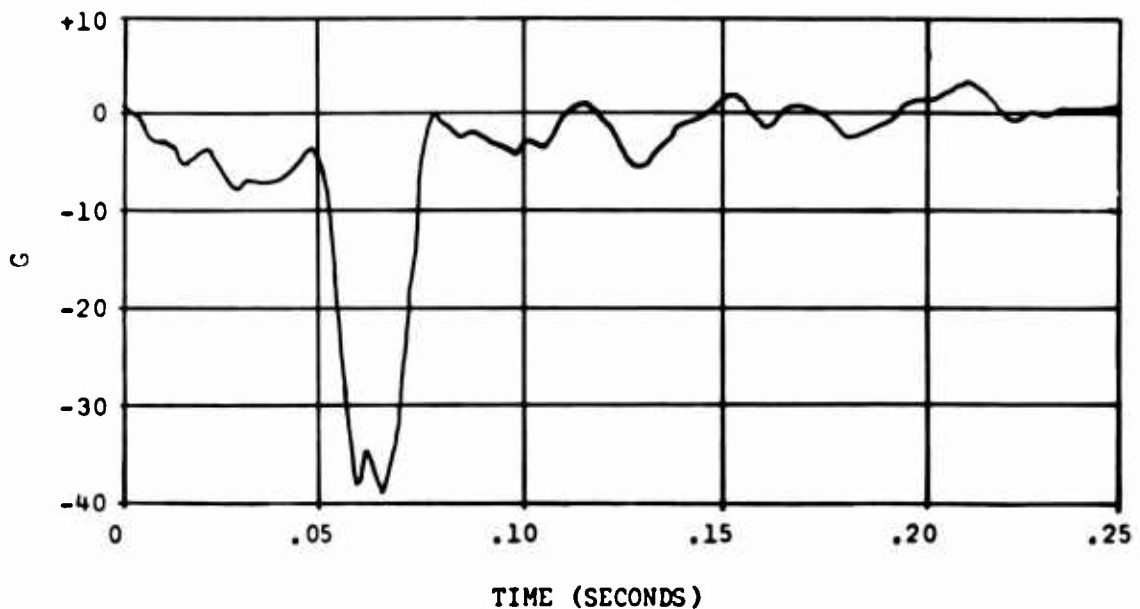
Figure 25. Vertical Acceleration-Time Plot of Passenger Floor, T-21.

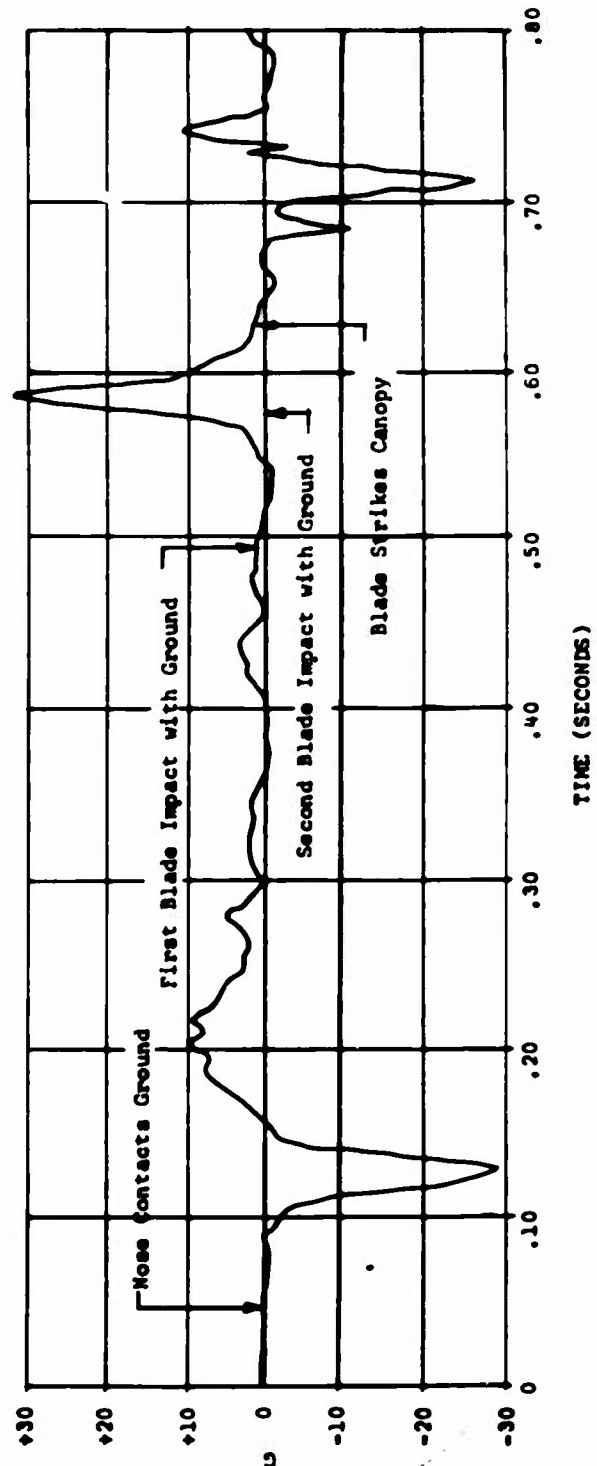
The OH-4A is a compact aircraft leaving little clearance between the occupant's head, the door, and the door and ceiling frames. The overhead control console between the heads of the pilot and the copilot may also present some hazard. The lateral head impacts for T-22 are shown in Figure 35. None of the pulses are considered injurious, since the human is quite capable of sustaining up to 4 to 5 times the acceleration levels recorded without injury due to brain damage. However, there is almost no data on the effect produced on neck vertebra and tissues due to head accelerations.

Figure 35. Pilot Lateral Head Acceleration-Time Plot, T-22.
